1426-1446 East Baltimore Street (Commercial Buildings)  
1432 East Baltimore Street  
Baltimore (Independent City)  
Maryland

HABS No. MD-904-C

WRITTEN HISTORICAL AND DESCRIPTIVE DATA

ARCHITECTURAL DATA FORM

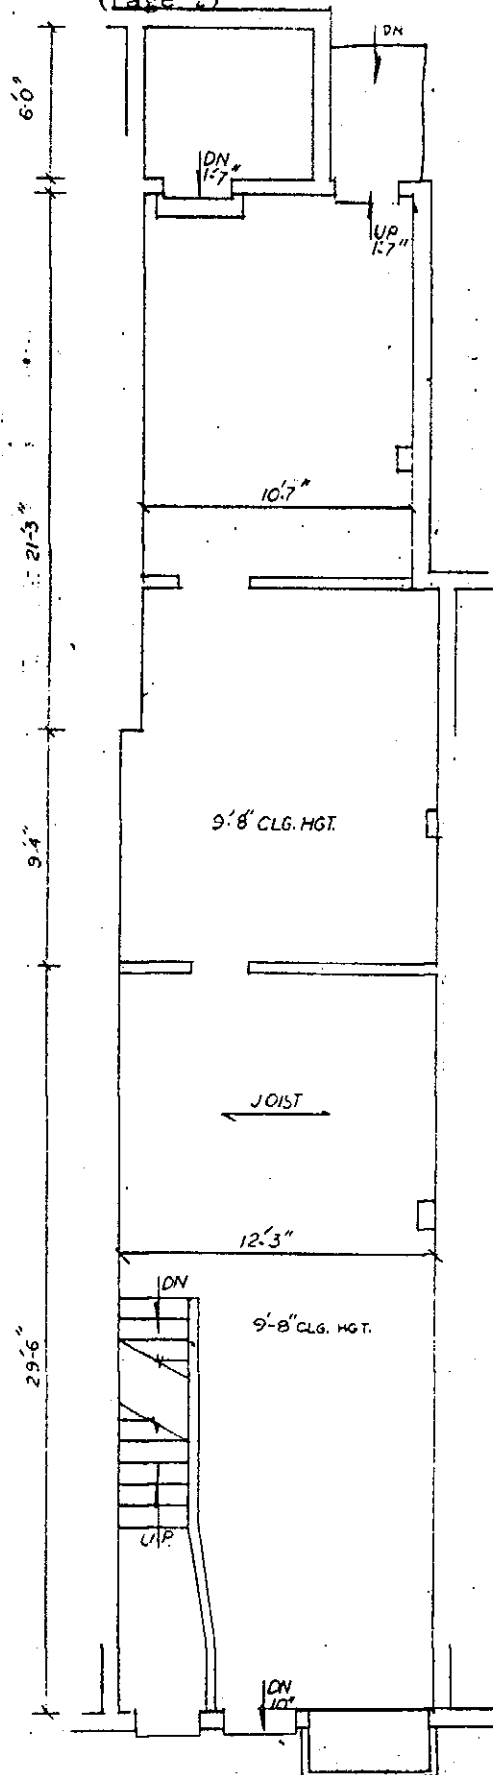
FIRST FLOOR

STATE Maryland	COUNTY	TOWN OR VICINITY Baltimore
HISTORIC NAME OF STRUCTURE (INCLUDE SOURCE FOR NAME) 1426-46 East Baltimore Street (Commercial Buildings)		HABS NO. MD-904-C
SECONDARY OR COMMON NAMES OF STRUCTURE 1432 East Baltimore Street		
COMPLETE ADDRESS (DESCRIBE LOCATION FOR RURAL SITES) 1432 East Baltimore Street		
DATE OF CONSTRUCTION (INCLUDE SOURCE) C. 1860 (1869 Sachsey Map)	ARCHITECT(S) (INCLUDE SOURCE) Unknown	
SIGNIFICANCE (ARCHITECTURAL AND HISTORICAL, INCLUDE ORIGINAL USE OF STRUCTURE) Original use presumed to be shop with residence above. Double entrance and storefront typical of this building type. Late 19th C. Commercial Building which contributes to streetscape.		
STYLE (IF APPROPRIATE) italianate influence		
MATERIAL OF CONSTRUCTION (INCLUDE STRUCTURAL SYSTEMS) Brick bearing walls; wood joists and floors; built-up roof; wood doors; windows and front.		
SHAPE AND DIMENSIONS OF STRUCTURE (SKETCHED FLOOR PLANS ON SEPARATE PAGES ARE ACCEPTABLE) Overall 13' x 66' Front 13' x 31' Rear 12' x 35' (see sketch plan)
